MAGNOLIA PIER CONDITION ASSESSMENT REPORT MAGNOLIA HARBOR Gloucester, Massachusetts

June 2018

File No. 18.0173724.00

GZA GeoEnvironmental, Inc.

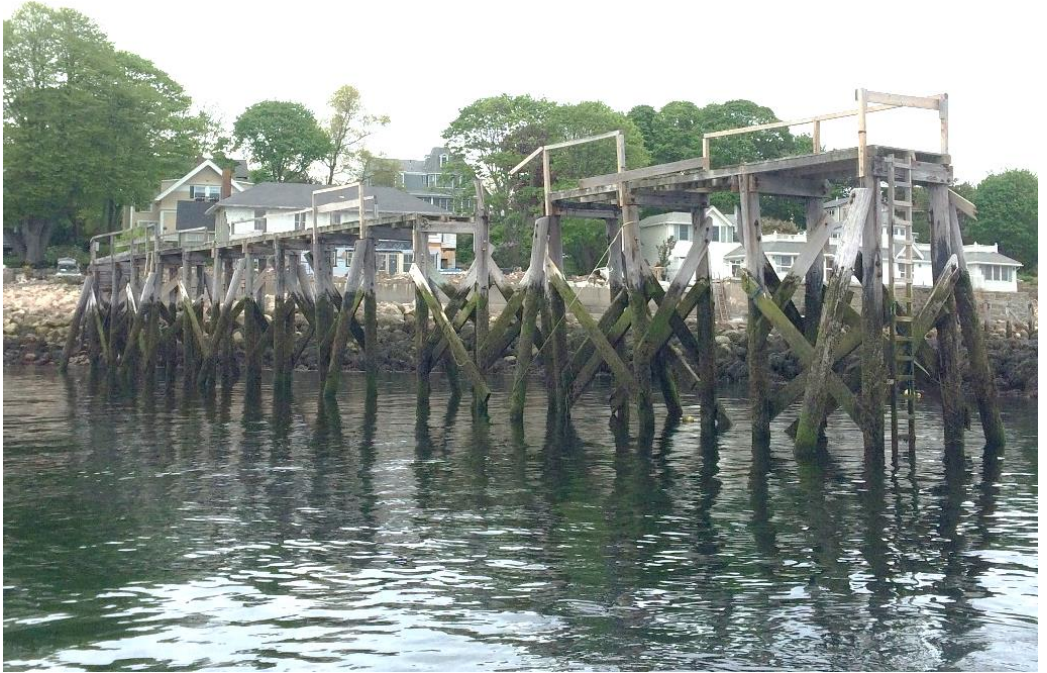
| Photo No. 5 | Date: 5/22/18 | | |

| Description: View of Magnolia Pier along outer north side | | | |

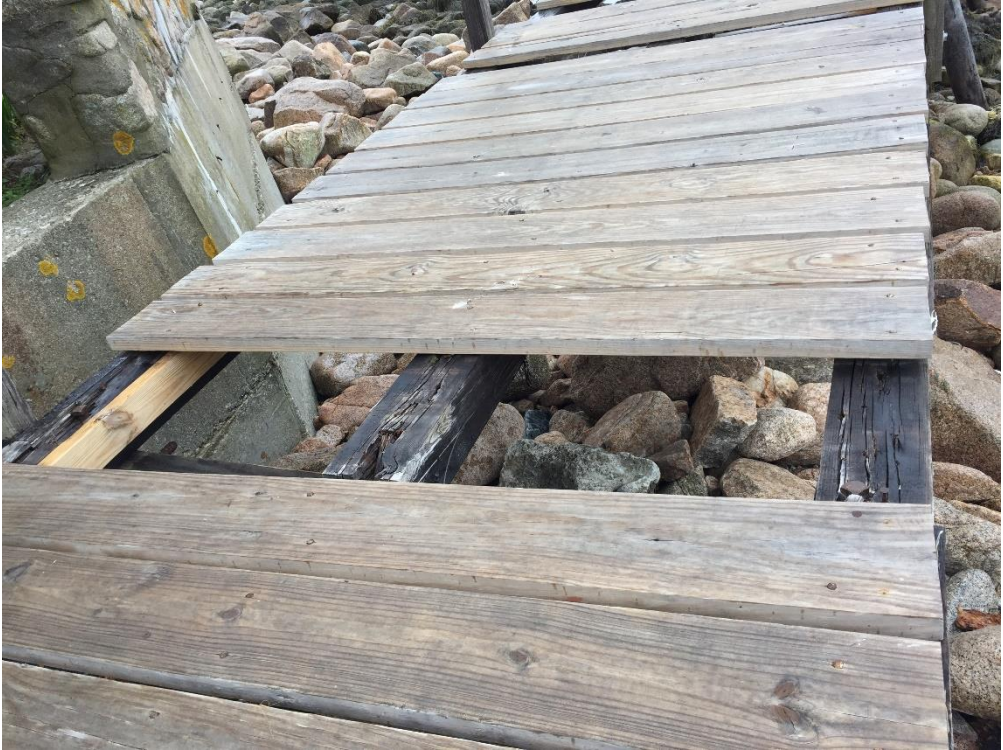
| Photo No. 7 | Date: 5/22/18 | | |

| Description: Moderate to major deterioration and splitting of stringers between Bents 1 and 2 | | | |

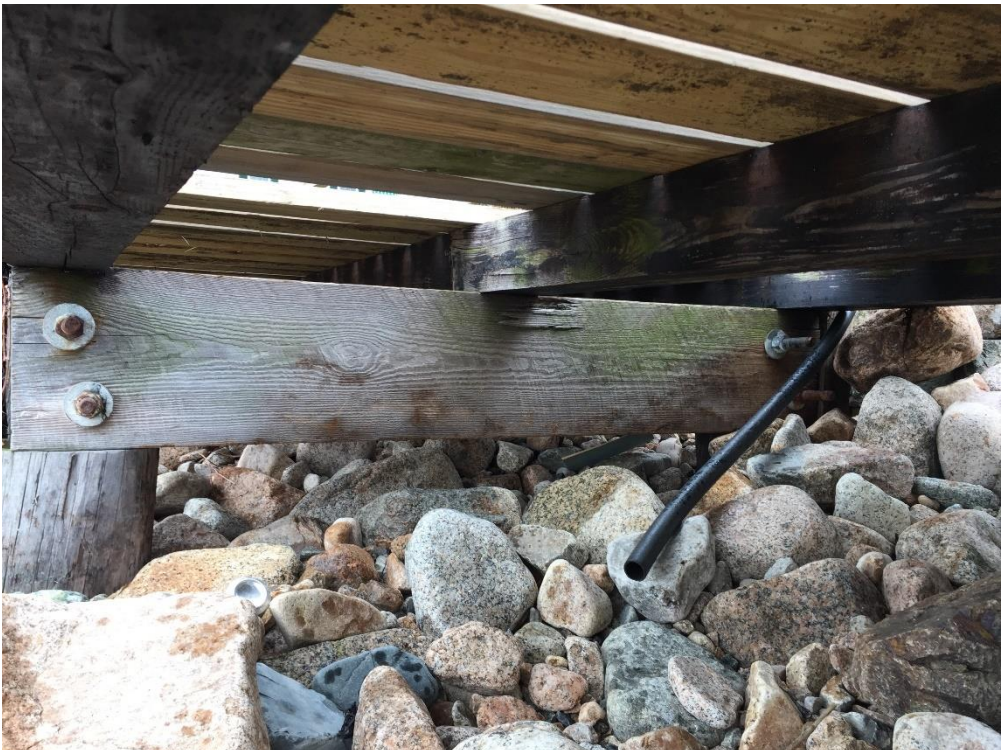
| Photo No. 8 | Date: 5/22/18 | |

The overall observed condition of the timber pile caps ranged from **Good** to **Critical**, with approximately 30 percent of the pile caps observed to have minor to moderate checks and splits and approximately 10 percent of the pile caps were observed to be missing, broken, or severely deteriorated (See Photographs 8, 14, 15). The pile cap members in Bent 22 were missing.

| Description: Crushing of pile cap under center stringer at Bent 1. | | |

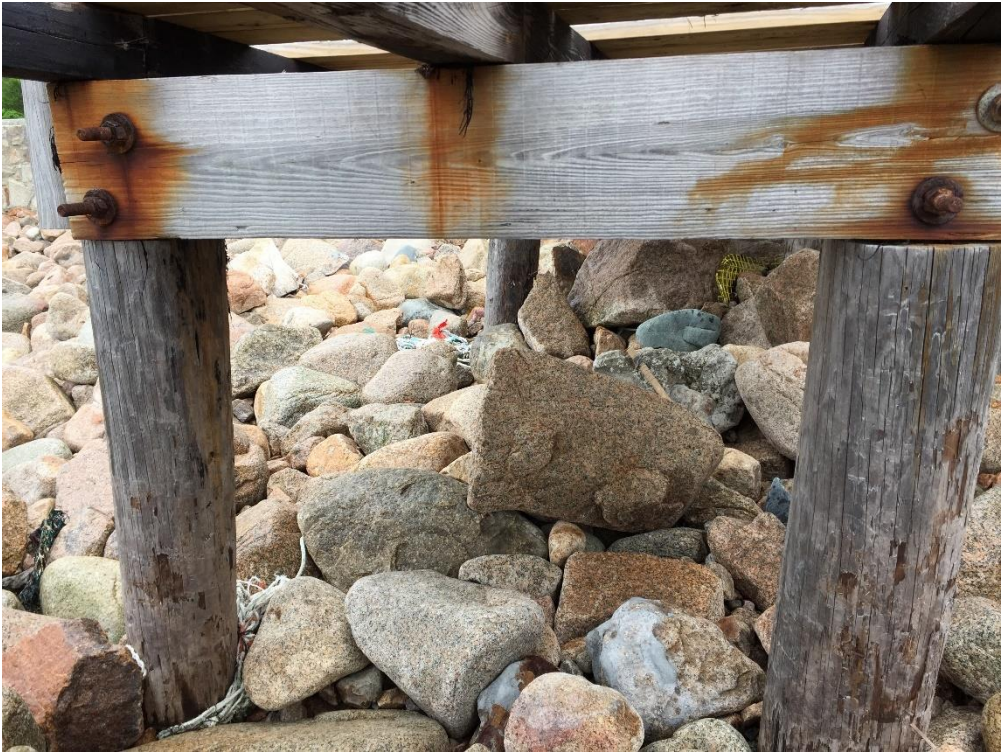
| Photo No. 9 | Date: 5/22/18 | | |

Minor to moderate deterioration, including delamination and marine borer damage along with rot, splitting and abrasion conditions, was observed on approximately 40 percent of the support (plumb) piles, and over 50 percent of the batter piles (See Photographs 6, 9, 19 to 24 and 27, 28). Moderate to severe corrosion was observed on the majority of hardware connections within the tidal zone (See Photographs 9, 18, 20, 25, 26).

| Description: Typical minor abrasion on timber piles at Bent 3 due to stone movement. Typical corrosion on hardware. | | | |

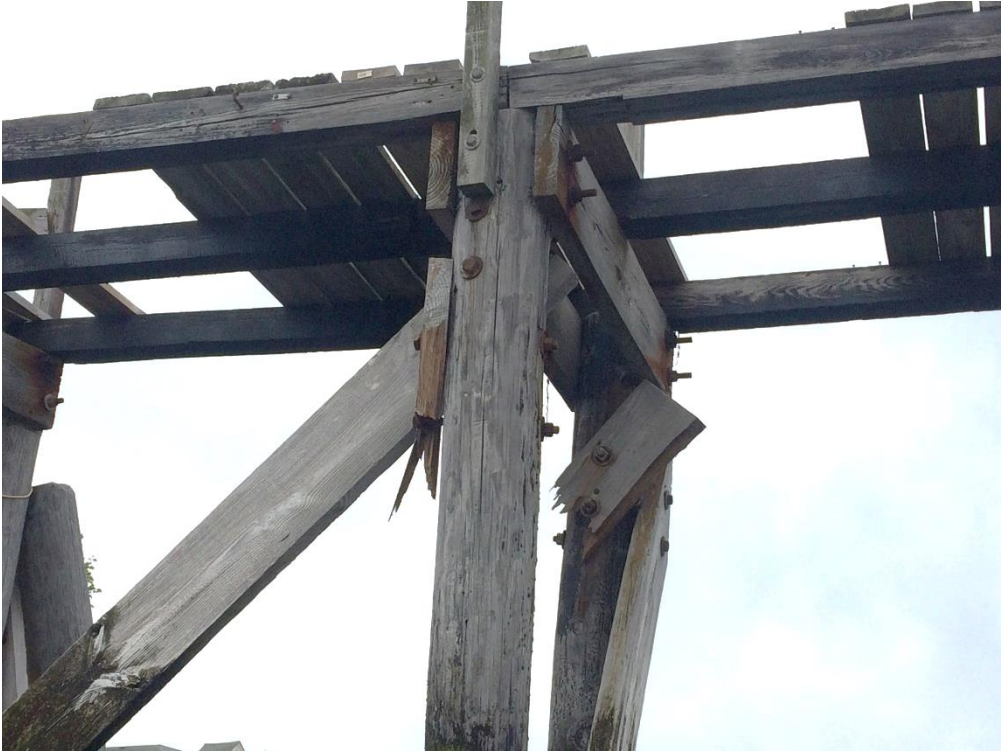
| Photo No. 10 | Date: 5/22/18 | | |

The overall observed condition of the bracing ranged from **Fair** to **Critical**, with approximately 30 percent of the bracing observed to be missing, broken/disconnected, or severely deteriorated. The majority of bracing members were observed to have minor to moderate checks/splits and trenching, along with minor to moderate damage due to marine borers within the tidal zone (See Photographs 10 to 12, 16 to 19, 22 to 26).

Approximately 30 percent of timber decking was observed to be missing with several other members deteriorated and partially and fully disconnected from the supporting stringers (See typical Photograph 10).

Approximately 40 percent of railing members were observed to be missing (See typical Photograph 10). See Table 2 in **Appendix D** for observed conditions of the pier framing, decking and railings.

| Description: Broken bracing, splitting on stringers, and missing decking between Bents 11 and 13. | | | |

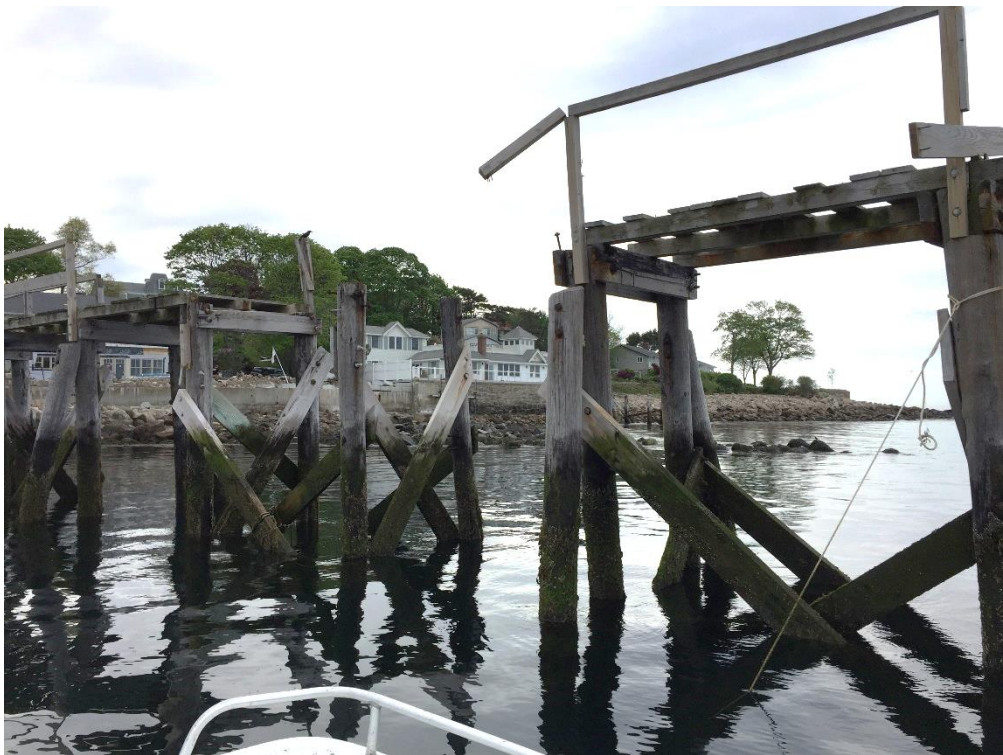
| Photo No. 13 | Date: 5/22/18 | | |

The overall observed condition of the timber stringers ranged from **Good** to **Critical**, with approximately 20 percent of the stringers observed to have minor to moderate checks and splits and approximately 15 percent of the stringers were observed to be missing, broken, or severely deteriorated (See Photographs 6, 7, 12). The stringers between Bents 15 to 26 were observed to be newer pressure-treated timbers whereas the stringers between Bents 1 to 15 were observed to be older creosote-treated timbers with the top of the members deteriorated in several locations. In general, the newer pressure-treated stringers were in **Good** to **Fair** condition with minor to moderate checks and splits. The timber stringers spanning from Bents 21 to 23 were missing.

| Description: Bents 21 to 23 missing various pier members including pile caps, bracing, stringers, decking, and railings. | | | |

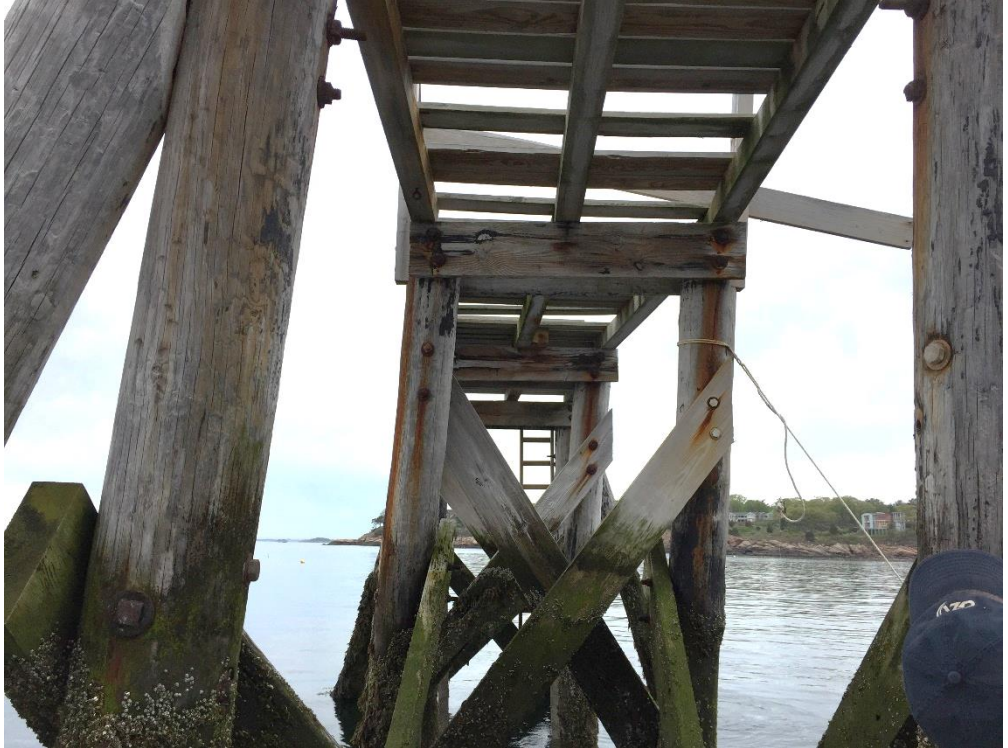
| Photo No. 15 | Date: 5/22/18 | | |

| Description: Bents 24 and 25 observed to be leaning/wracked to the north. | | | |

At a minimum, we recommend that the 8 plumb piles observed to be wracked/leaning and/or observed to have major to severe deterioration be repaired or replaced immediately. We recommend that the 22 plumb piles observed to have moderate deterioration, splitting, abrasion, and/or marine borer action should be replaced. Piles to remain should be considered to be programmatically repaired or replaced within 5 years, or sooner if conditions worsen. The plumb piles observed to have minor deterioration, splitting, abrasion, and/or marine borer action should be considered to be repaired or replaced within 5 to 10 years, or sooner if conditions worsen. Additional options to be considered for piles with minor to moderate damage include, but are not limited to:

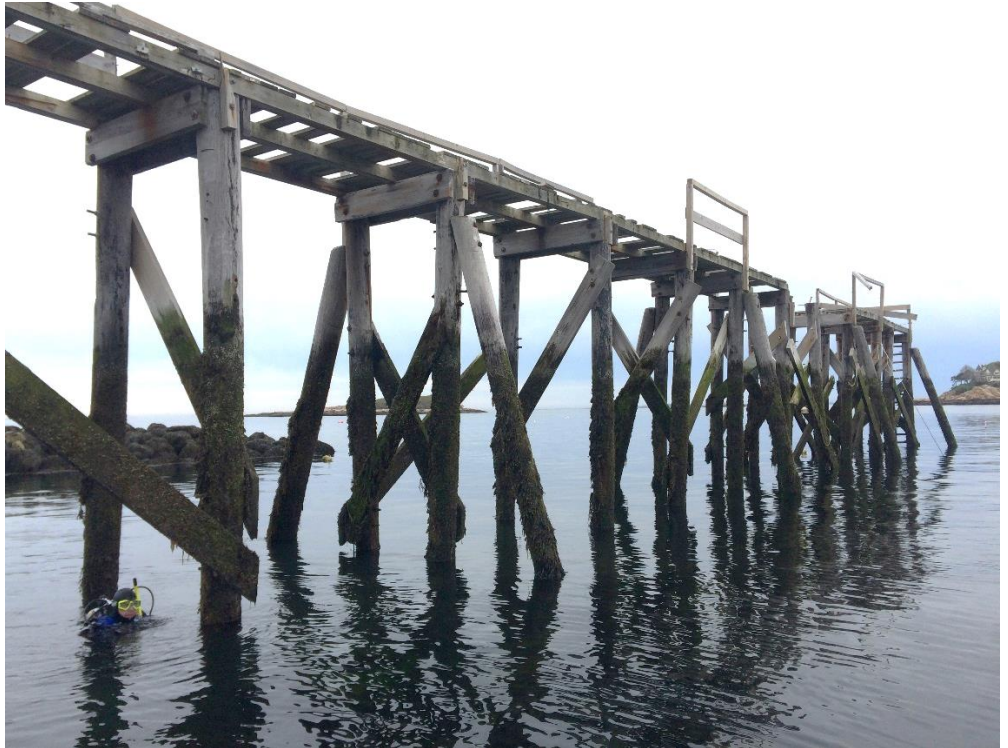
| Photo No. 16 | Date: 5/22/18 | |

| Description: Outer portion of pier with missing bracing, railing, and decking members | | |

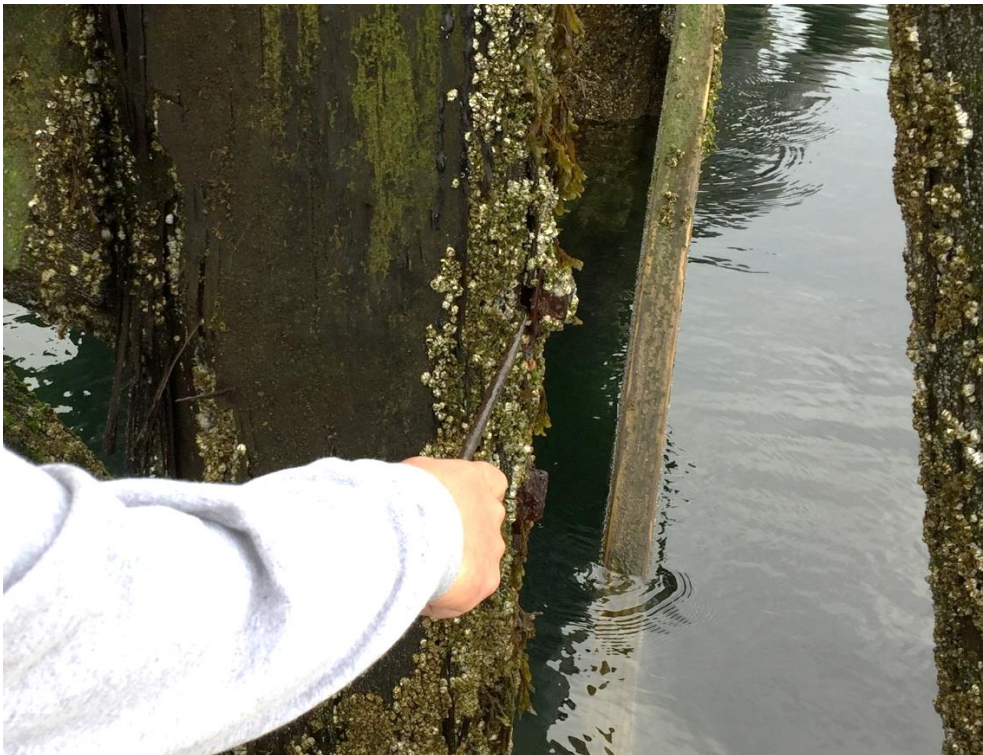
| Photo No. 18 | Date: 5/22/18 | |

| Description: Broken bracing and loose and deteriorated fastener | | |

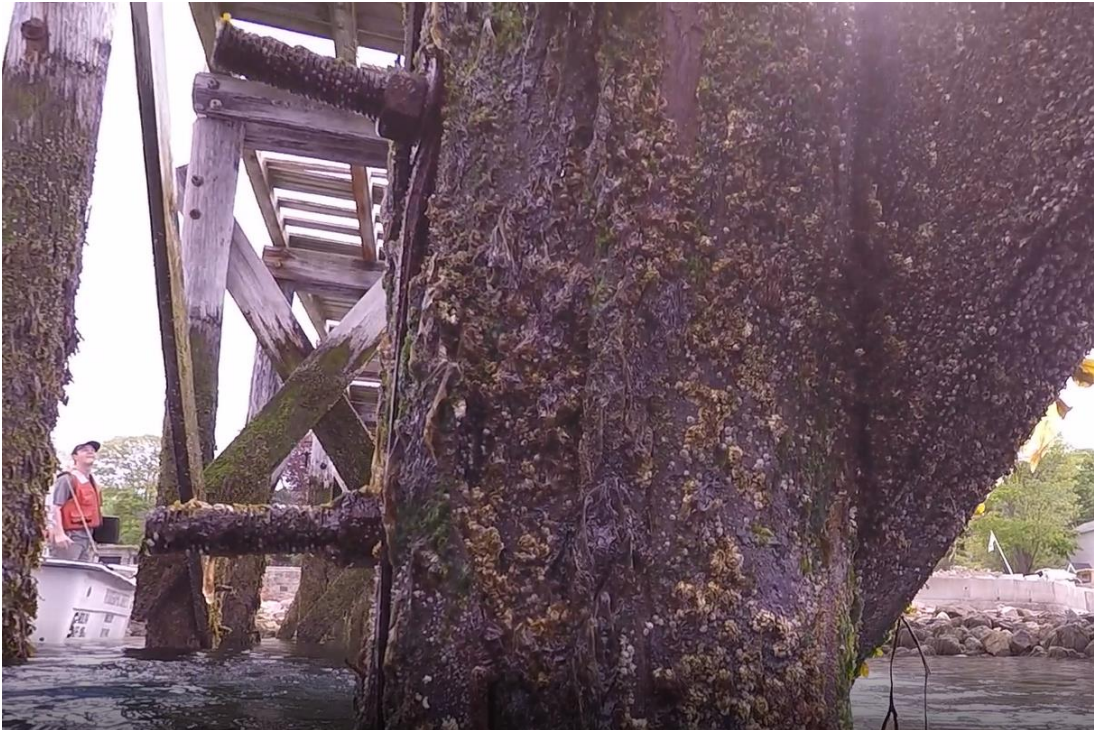
| Photo No. 20 | Date: 5/22/18 | |

| Description: Typical minor to moderate deterioration and splitting of timber pile B21C within tidal zone. Typical corrosion on hardware. | | |

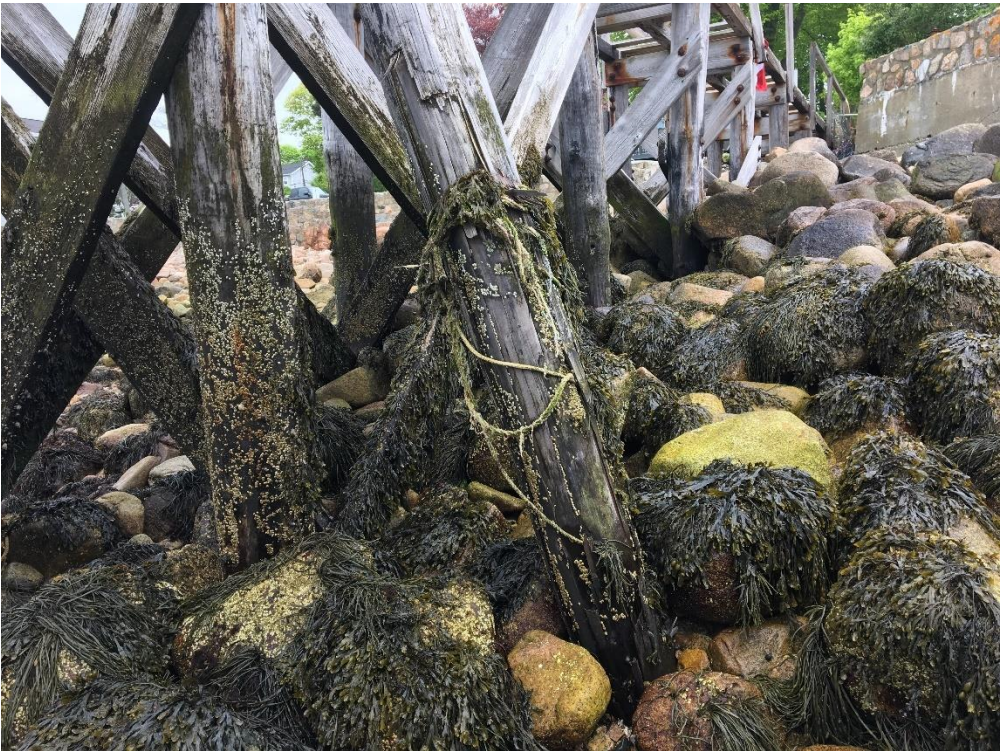
| Photo No. 21 | Date: 5/22/18 | | |

| Description: Typical moderate to major deterioration/ delamination and abrasion on timber pile B8D within the tidal zone. | | | |

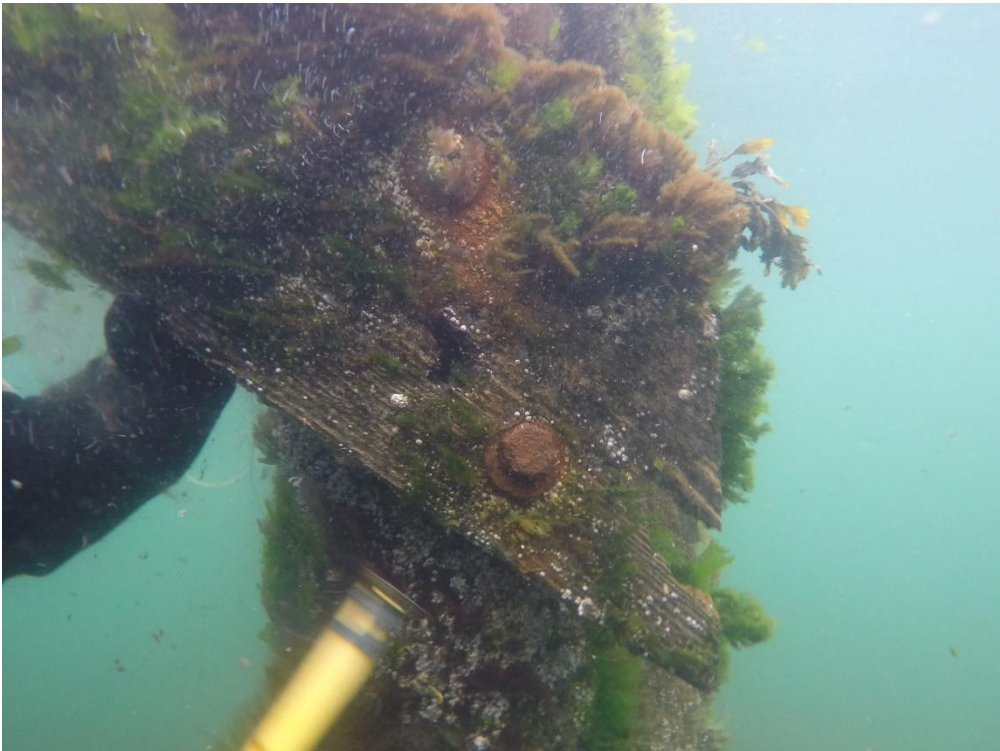
| Photo No. 25 | Date: 5/22/18 | | |

| Description: Typical minor to moderate deterioration and splitting of lower cross bracing at Bent 26. | | | |

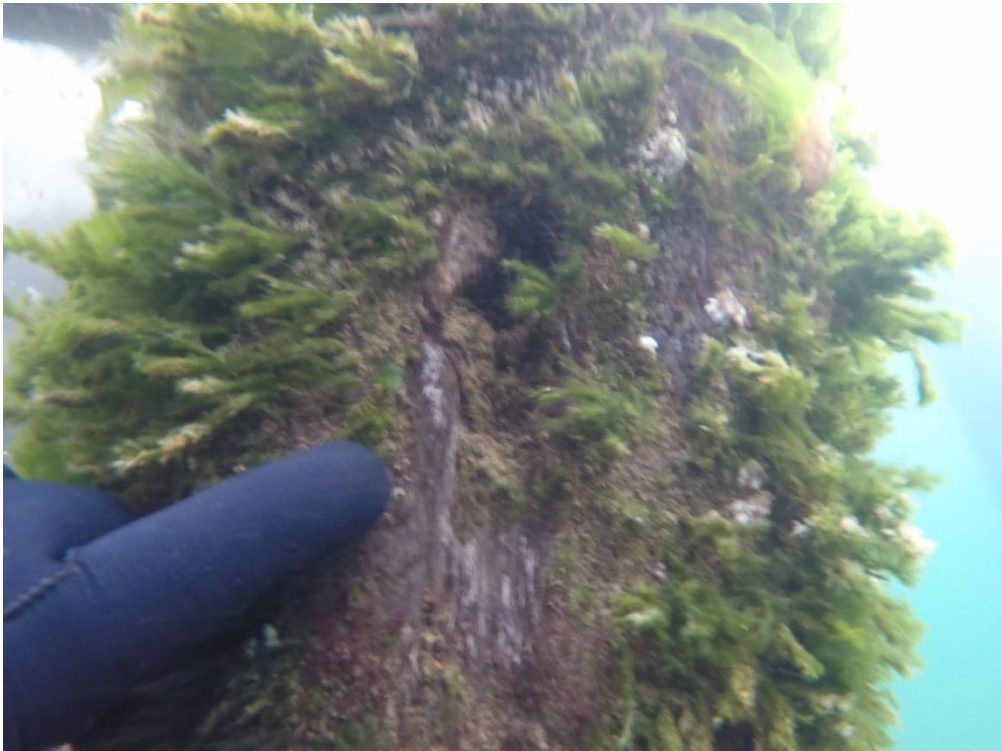
| Photo No. 27 | Date: 5/22/18 | | |

| Description: Typical minor to moderate marine borer damage on timber piles B25B. | | | |

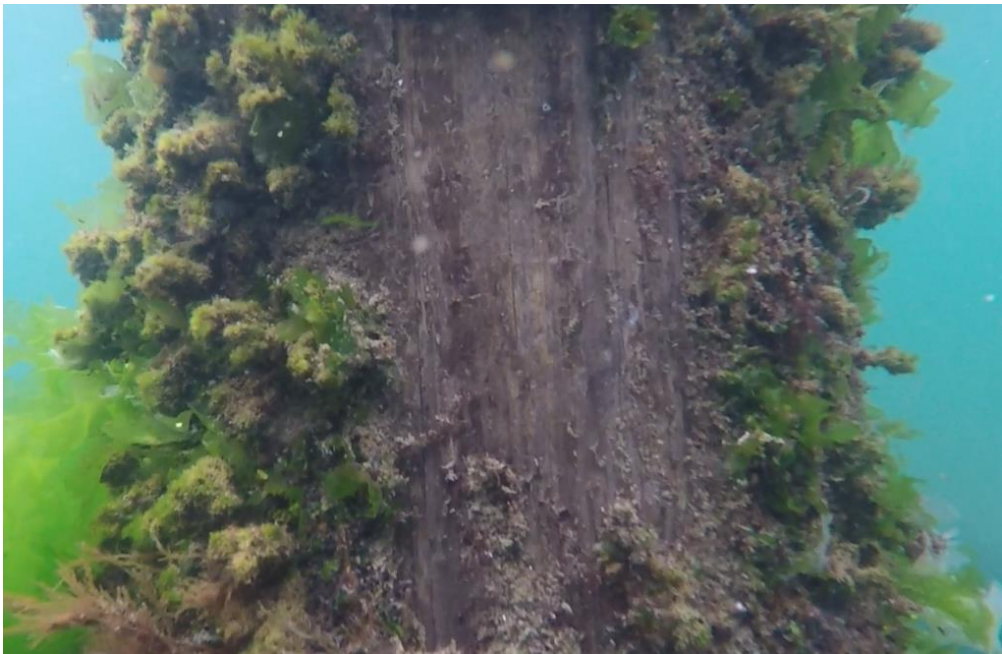
| Photo No. 28 | Date: 8/21/15 | |

| Description: Typical minor to moderate delamination on timber pile B26D within tidal zone. | | |
